## CAT GIRDLE INFORMATION.

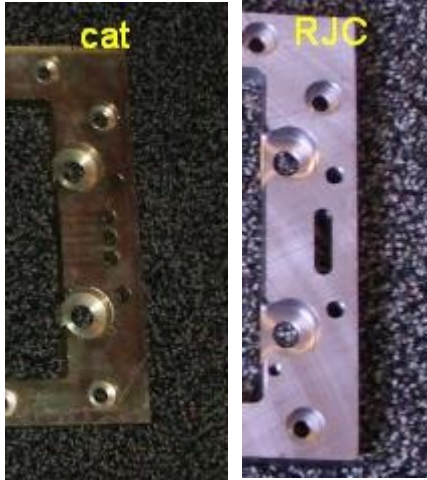
### **#1 DESIGN FLAW:**

This is an exact duplicate of my Revision A girdles that i made when nearly a decade ago when we first developed them. These girdles had an inherent flaw in the design that caused them to leak oil. This is what attributed to reputation that girdles leak oil. The crank throw windows were much smaller to add as much "beef" to the girdle as possible.

Although that sounds good on paper it causes the girdle to extend into crank area creating a lip for the oil spray off of the crank to hit. This feeds the oil directly into the seams between the pan rail portion of the block and the girdle and seam between the girdle and the oil pan. This makes it extremely difficult to get them to seal up and not leak oil. Luckily we only sold a few of these before we realized the problem.

We offered to re-machine these girdles to all of our customers free of charge. The machine work to fix them is expensive but at the time we had so few of them in the field we were able to absorb this cost. At the rate a select few of the distributors are selling them it will be very expensive problem. This design flaw also makes it so the RJC crank scraper absolutely will not work. Since RJC addressed this problem we do not have any issues related to this problem area.

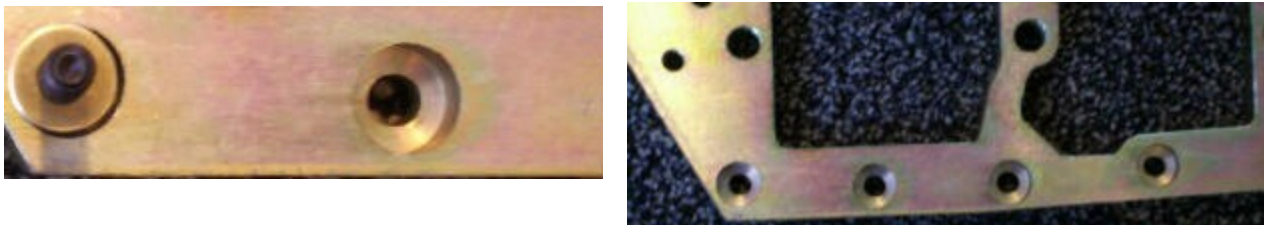
## #3 PANRAIL HOLES;

The pan rail holes in the girdle were not in the correct location. We had to slot 8 of the 20 holes to get it to fit a standard Buick 20 bolt block. Once we slotted the hole we could install the girdle but now the counter bore was off from our newly slotted hole enough that we could not use the sealing washers. This took us more than an hour just to get the girdle to fit onto the block. This is just plain unacceptable quality.

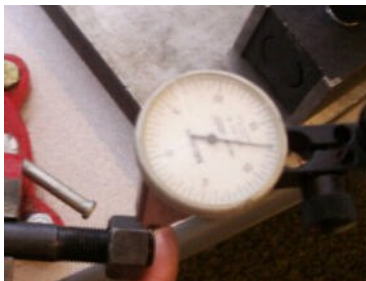
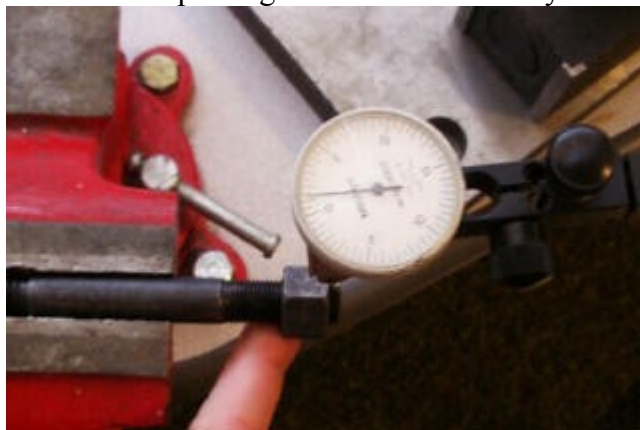
## #4 FASTENERS;

All of the studs are of typical Chinese quality. Nothing ARP here. The thread on the nuts and studs are out of tolerance even if checking to the loosest lowest standard ANSI UN thread tolerances) on the nuts and studs you can see this "slop" just by feeling the difference between the nut and the stud after spinning one of the main nuts on. Shown below in the pictures is the combined result of the poor quality main nut and main stud. We measured close to .015 of slop between the two. This is a huge amount considering how fine the threads are. Even the stock bolts are a much better fastener than these studs. These studs did hold the required 100 ft/lbs of torque but there is significant more load on the fasteners when the engine is running and the crank is spinning some RPM. Will they hold? Only time will tell.
